**Maryland Historical Trust**  
**State Historic Sites Inventory Form**

Survey No. **WA-III-074**

historic Frame house

18950 Sandy Hook Road 7/21/45

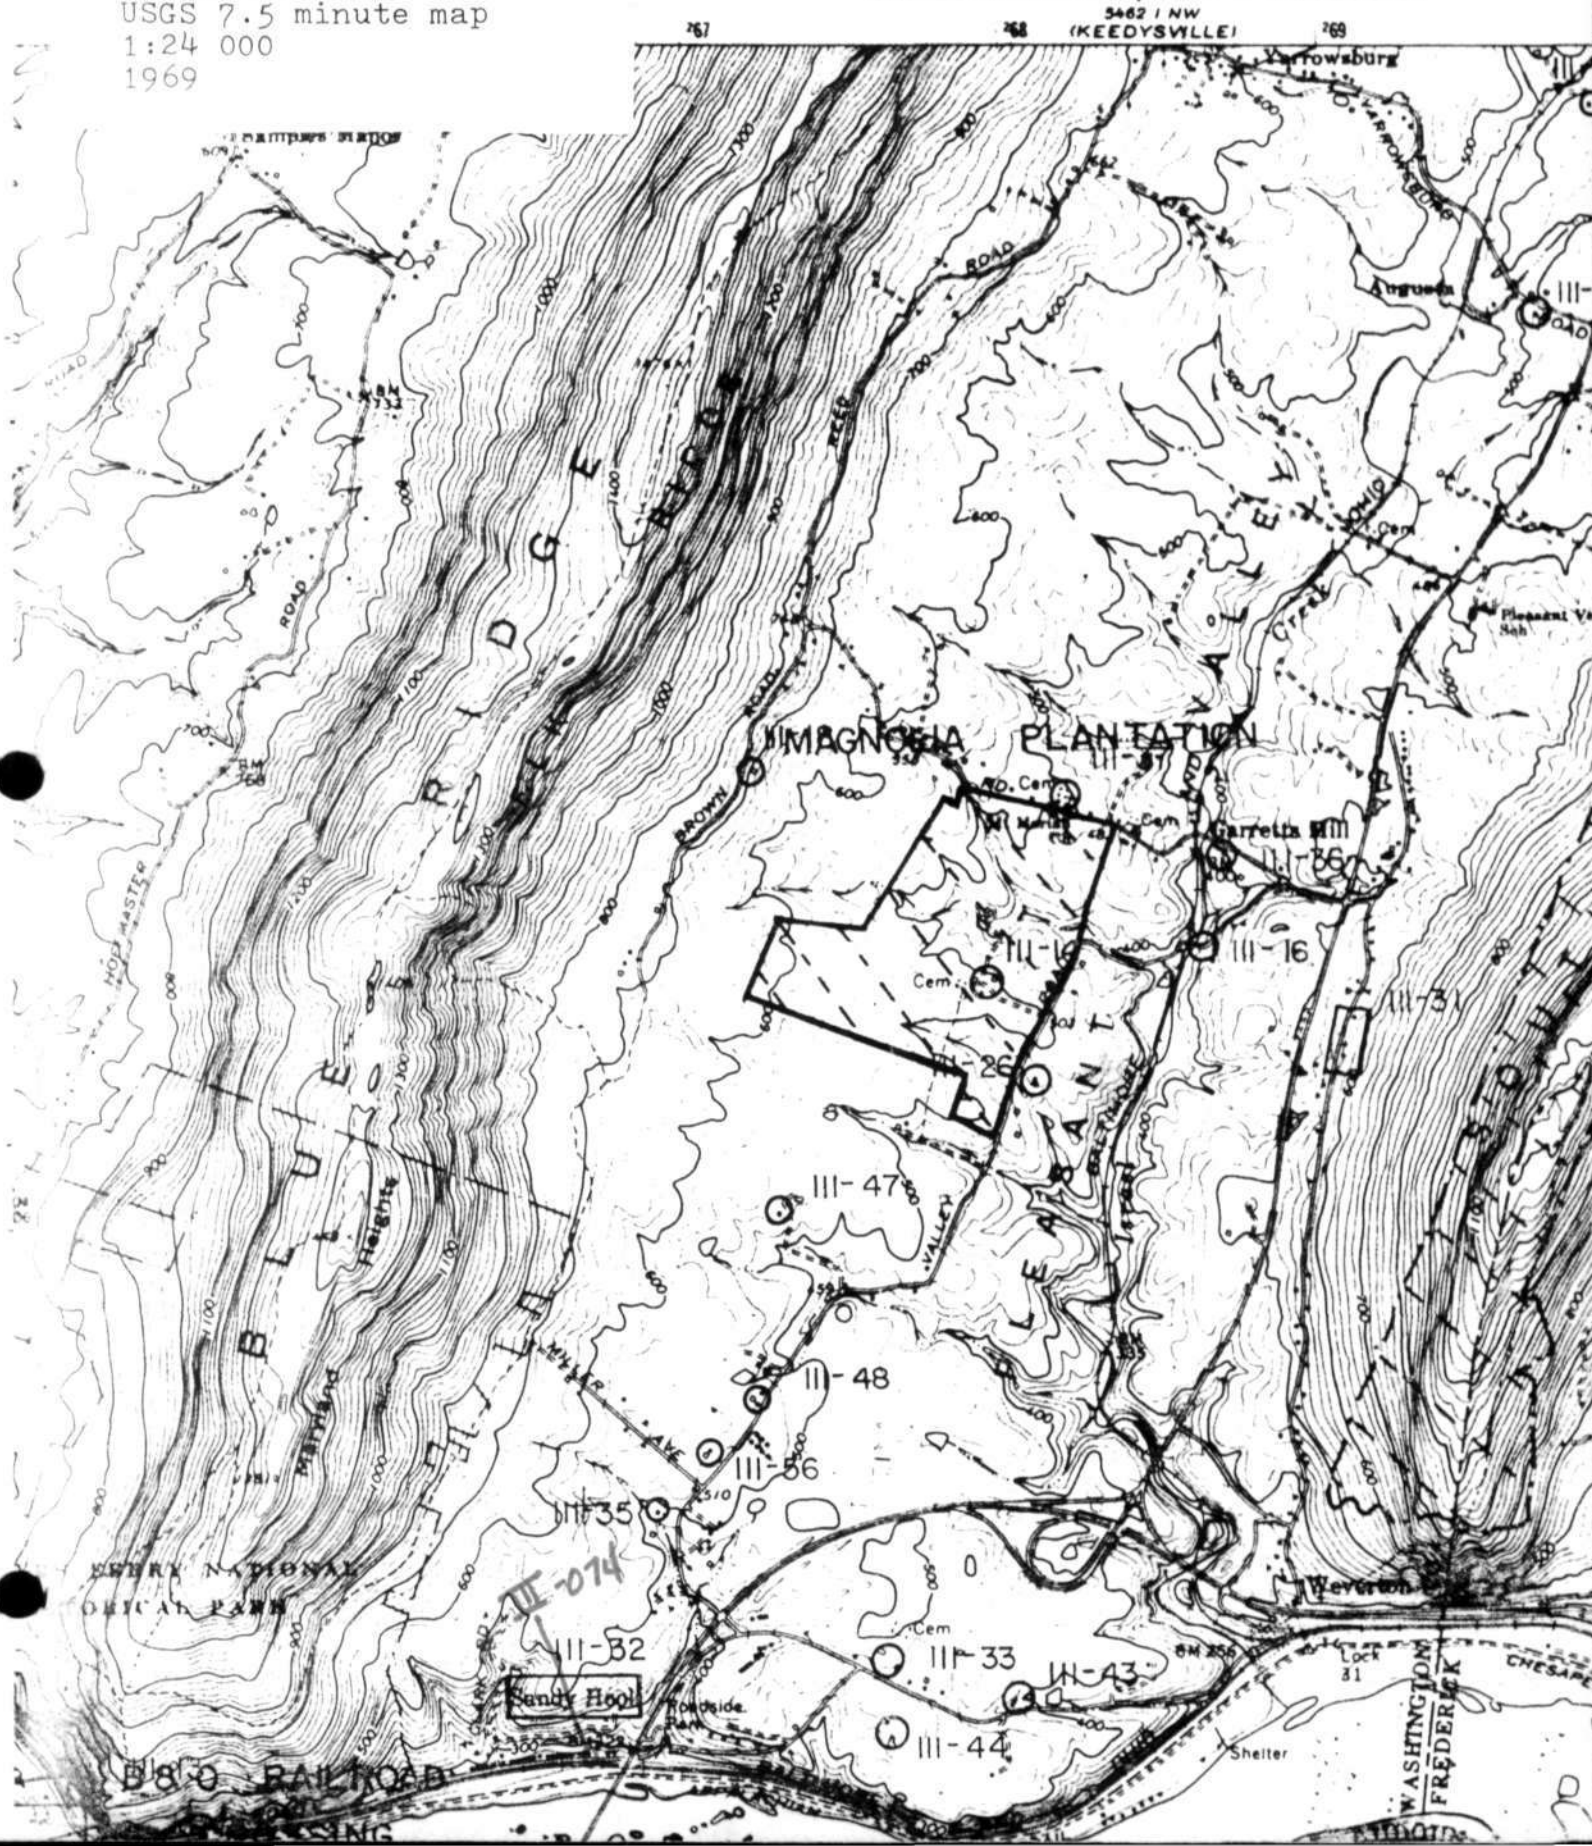
1. WA-III-074
2. Washington Co., Md.
3. Joe Getty
4. ~~April 1983~~ 7/82
5. Md. Hist. Trust, Annapolis, Md.
6. South elev. (camera facing north)
7. 1/1

The two story structure is constructed of frame covered in asphalt siding on a fieldstone foundation. The main facade is symmetrically arranged with the two central bays containing entrances. The entrances are spaced close together. Two-over-two sash windows with plain trim are in the outer bays of the first story. On the second, one-over-one sash windows are in the outer bays. The windows in the two central bays have been boarded over. The full length, one-story porch has a hipped roof and is supported on square posts with paneled railings. The porch is supported by a high brick foundation. The single bays on the gable ends have windows on each story. The second story windows contain six-over-six sash probably close in design to the original sash of the house. The one-bay wing has been remodeled and is presently covered in asphalt shingle. The gable roof has a boxed cornice. Rebuilt brick chimney stacks rise interior-end from each gable.

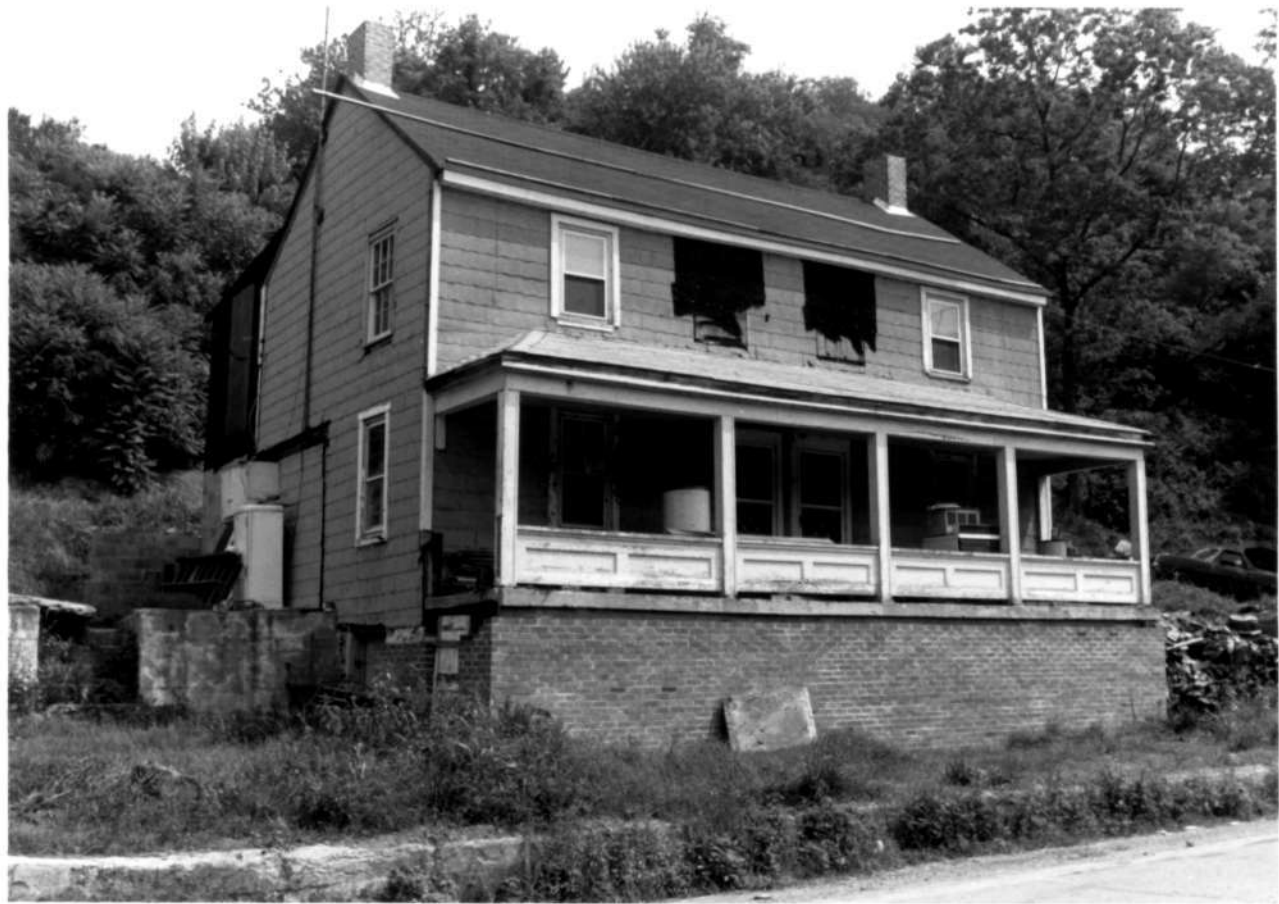
The frame house is a two story frame structure constructed in a L-shape plan. It has a four-bay by one-bay main section with a one-bay ell. The main facade is symmetrically arranged with entrances in the central two bays and a full-length, one-story porch. The exterior of the structure is covered in a asphalt siding. It has a gable roof covered in asphalt shingles. This structure appears to date from the late 19th century.
